# New York State Department of Transportation

## Yellow Flag NB2358W018

**BIN: 1065318**

Location: Span 165, Girder G19 at Pier 165

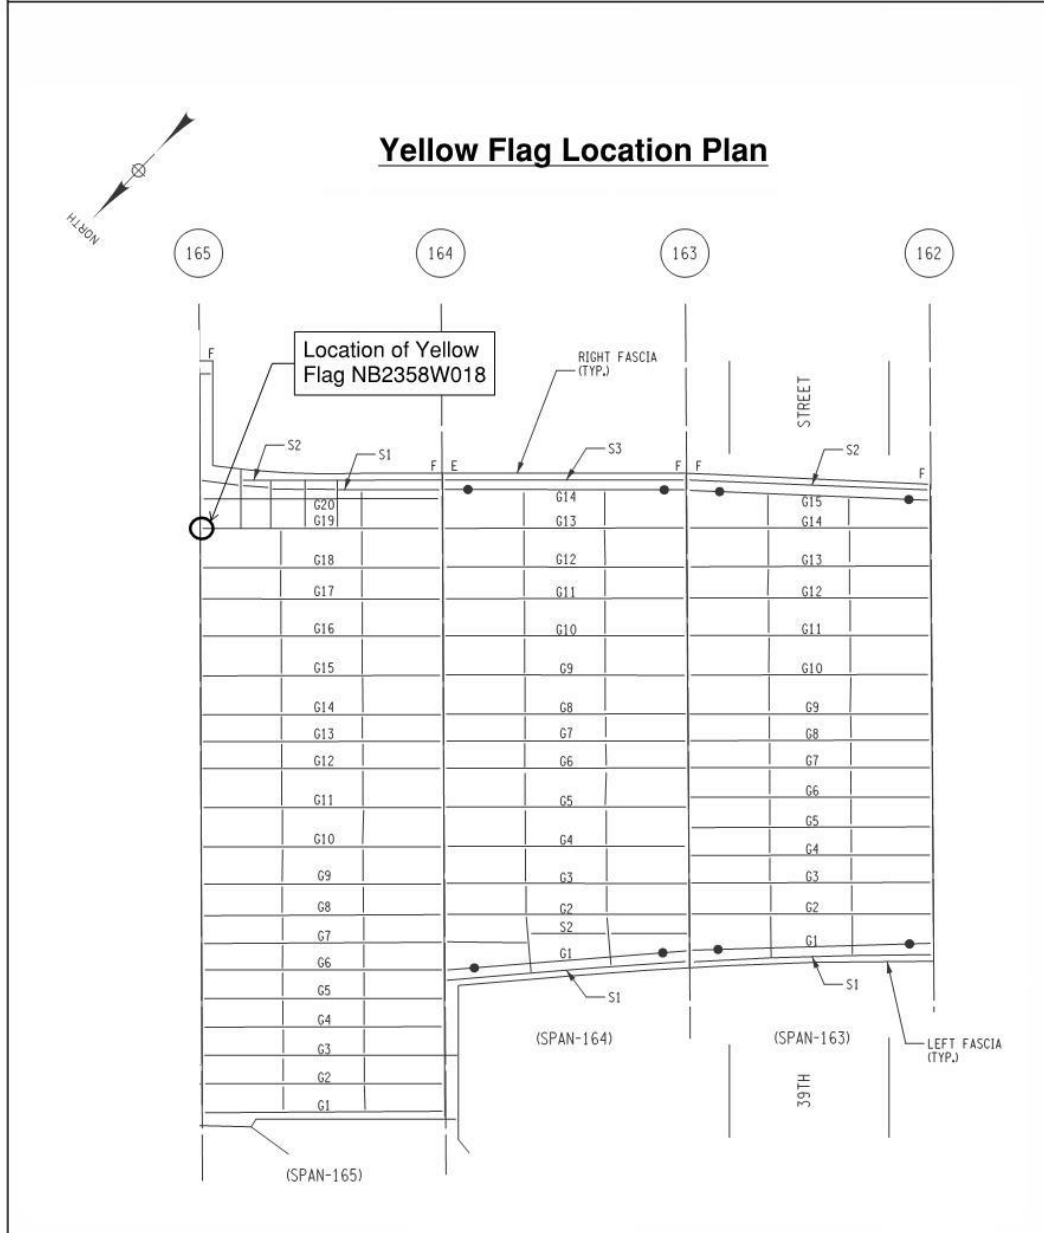
**Flag Photographs**Photo Number: **1**Photo Filename: **23\_Flag Location Plan.jpg**Gowanus Expressway  
2023 Biennial Inspection - Field SketchBIN: 1065318Team: AA/TSDate: 06/01/2023Span: 165Location: Girder G19 at Pier 165

**wsp****Attachment Description: Flag Location Plan**

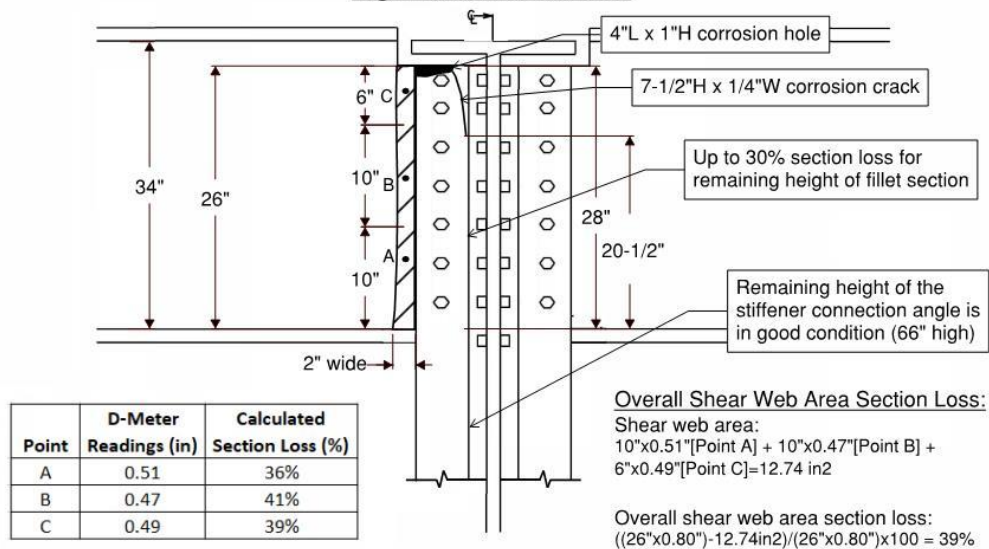
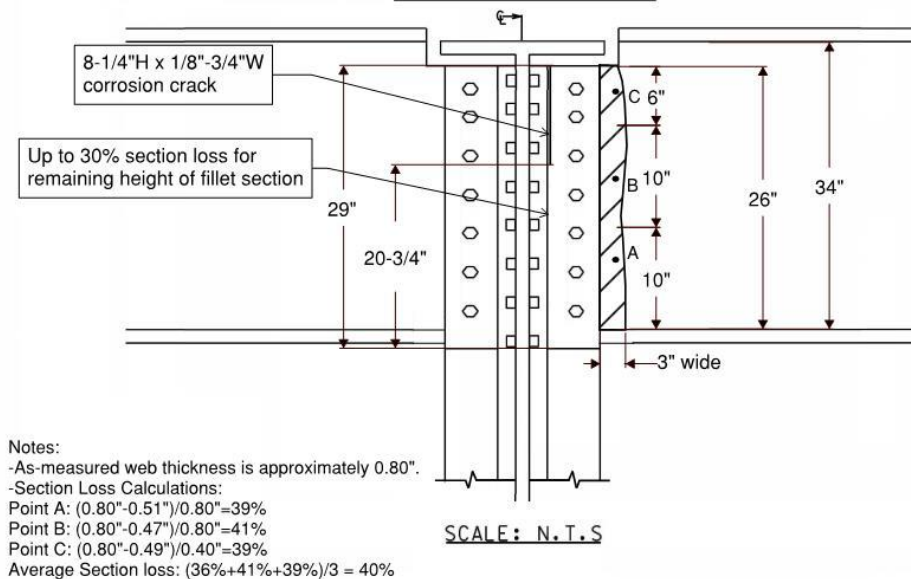
Photo Number: 2

The end of Girder G19 at Pier 165 exhibits section loss for the full web height along the connection angles for up to 3" wide with remaining thickness measured ranging from 0.47"-0.51" resulting in average section loss of 40%. The overall shear web area section loss is approximately 39% (Photos 5 and 8).  
(refer to Yellow Flag Condition Sketch Photo #2 for more details)

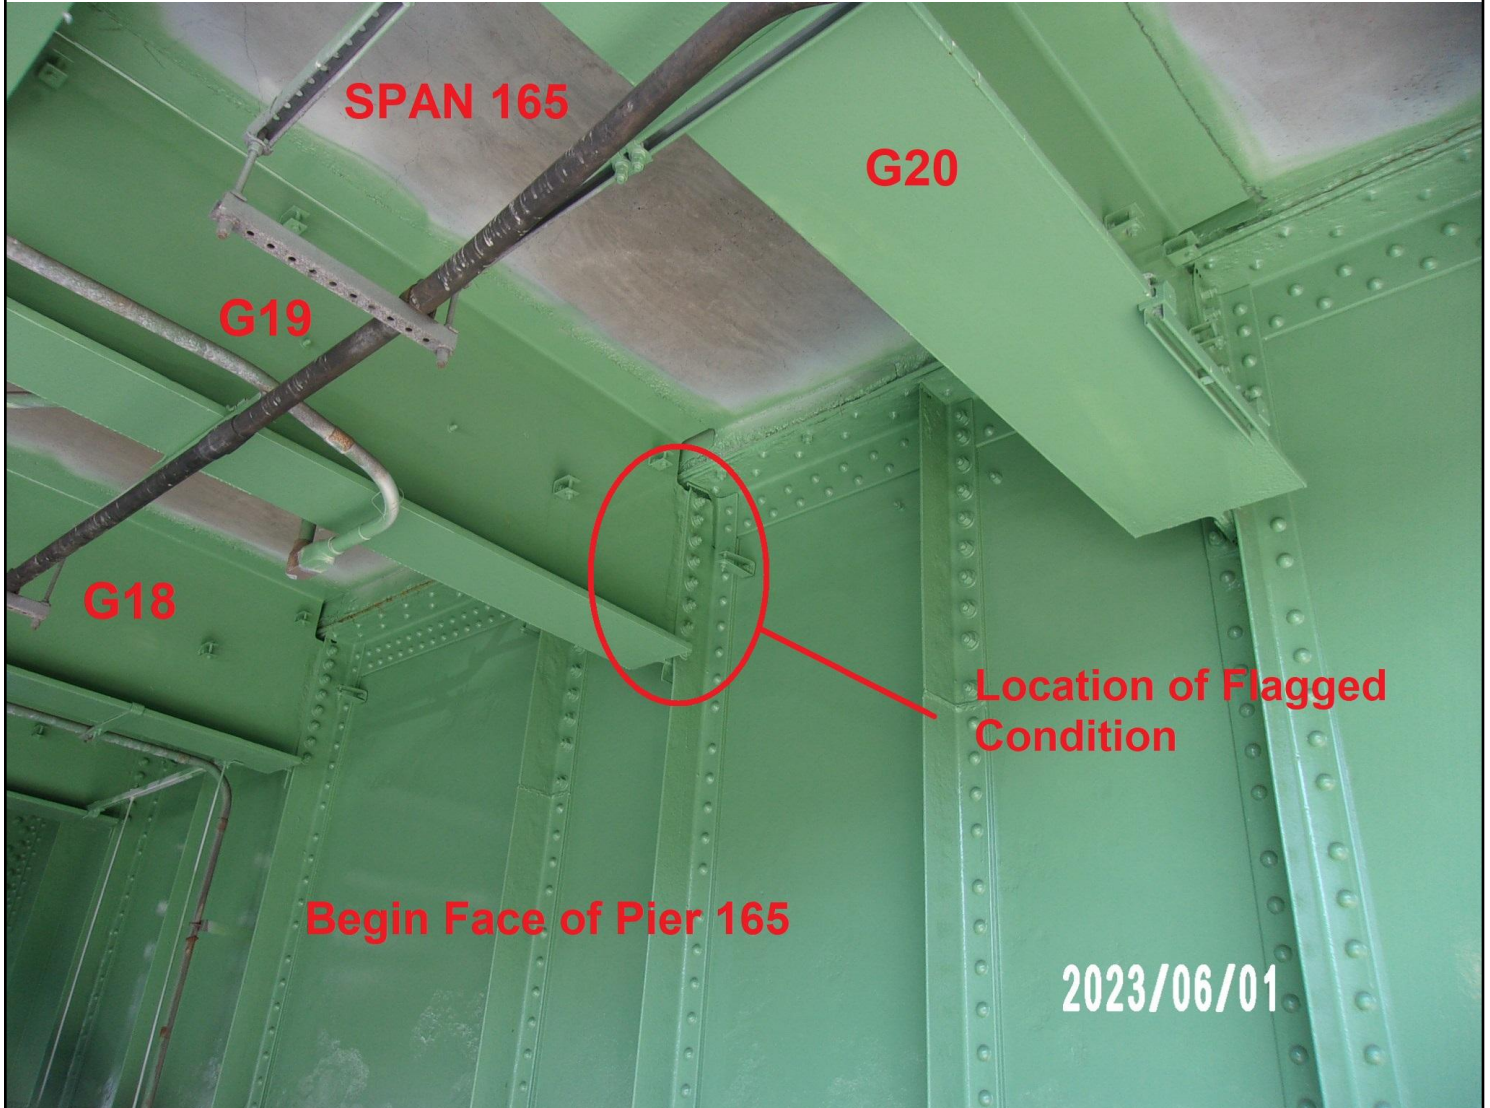
Photo Number: 3

**Attachment Description:** General view of the flagged condition at Girder G19 in Span 165 at Pier 165. Looking End and Left.

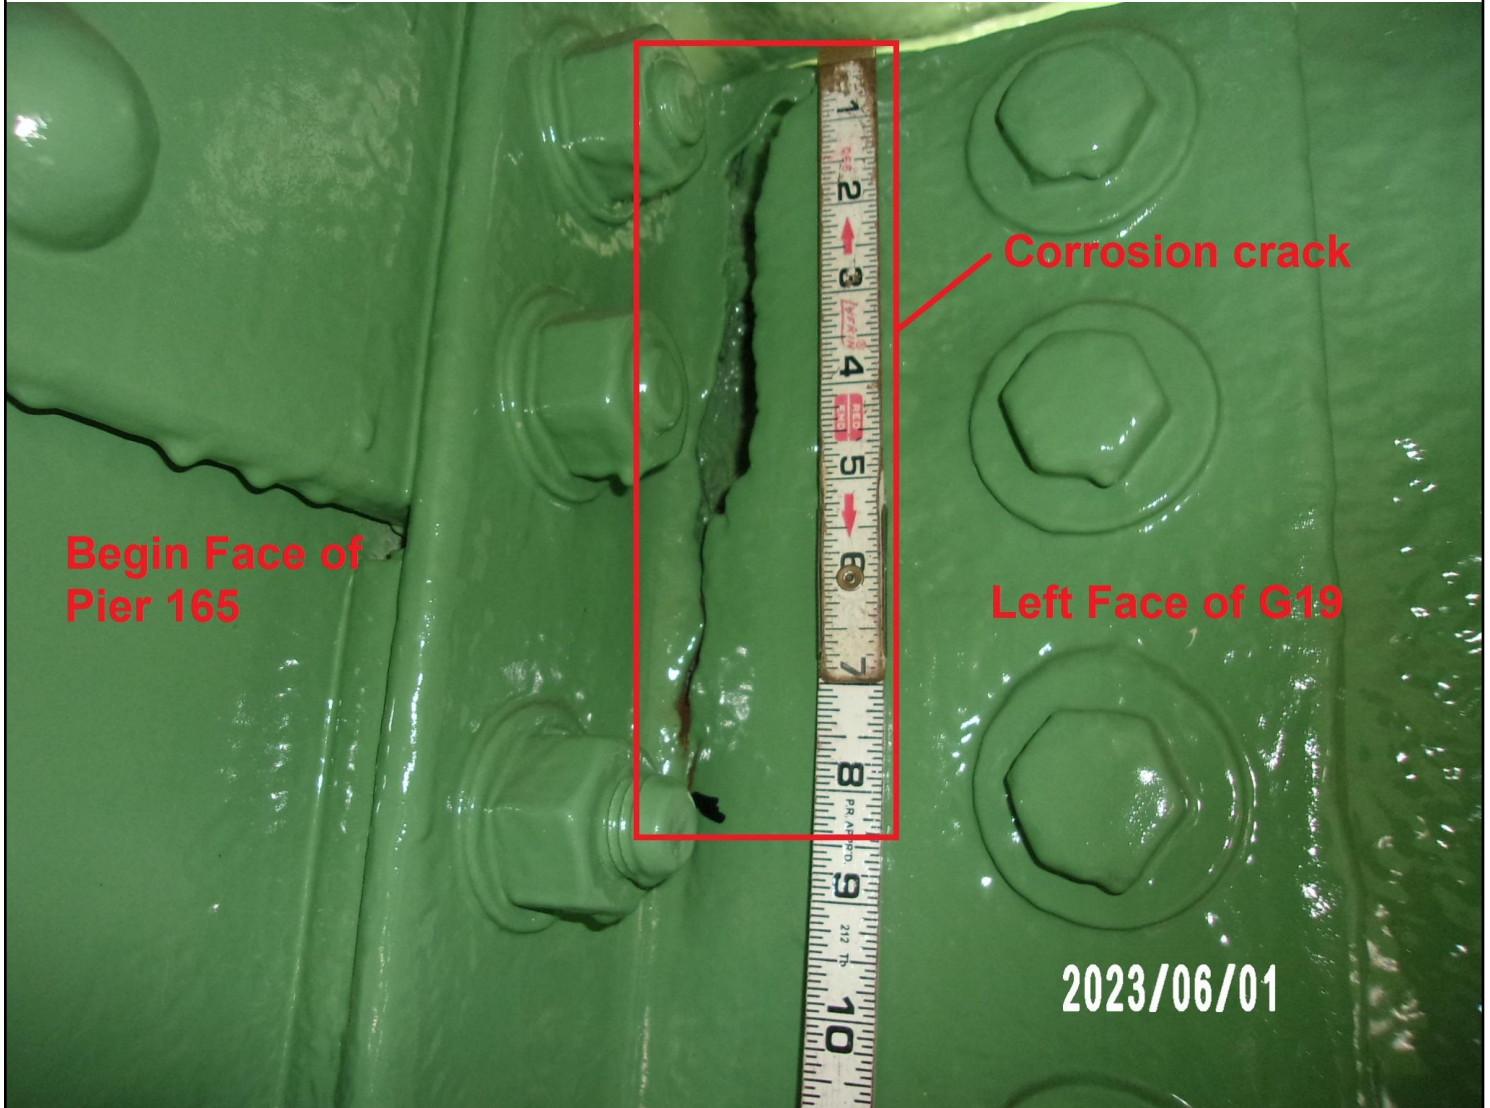
Photo Number: 4

The left connection angle at Girder G19 connection to the pier cap at Pier 165 exhibits a 8-1/4"H x 1/8"-3/4"W (previously 9" long but since the girder has been recently cleaned and painted then the limits of the crack were determined) vertical corrosion crack at the upper fillet section (Photo 4). The remaining 20-3/4" area of the fillet section below the corrosion crack at the top of the angle exhibits up to 30% section loss (Photo 5). The bottom of the left connection angle exhibits 2-1/4"L x 1"H corrosion hole (previously 2" long), one 1/4" diameter corrosion hole (new condition), and one 1/2" diameter corrosion hole (new condition) (Photo 6).

**Attachment Description:** The left face of Girder G19 in Span 165 at Pier 165. The top of the left connection angle exhibits 8-1/4"H x 1/8"-3/4"W corrosion crack at the fillet section. Looking Right.

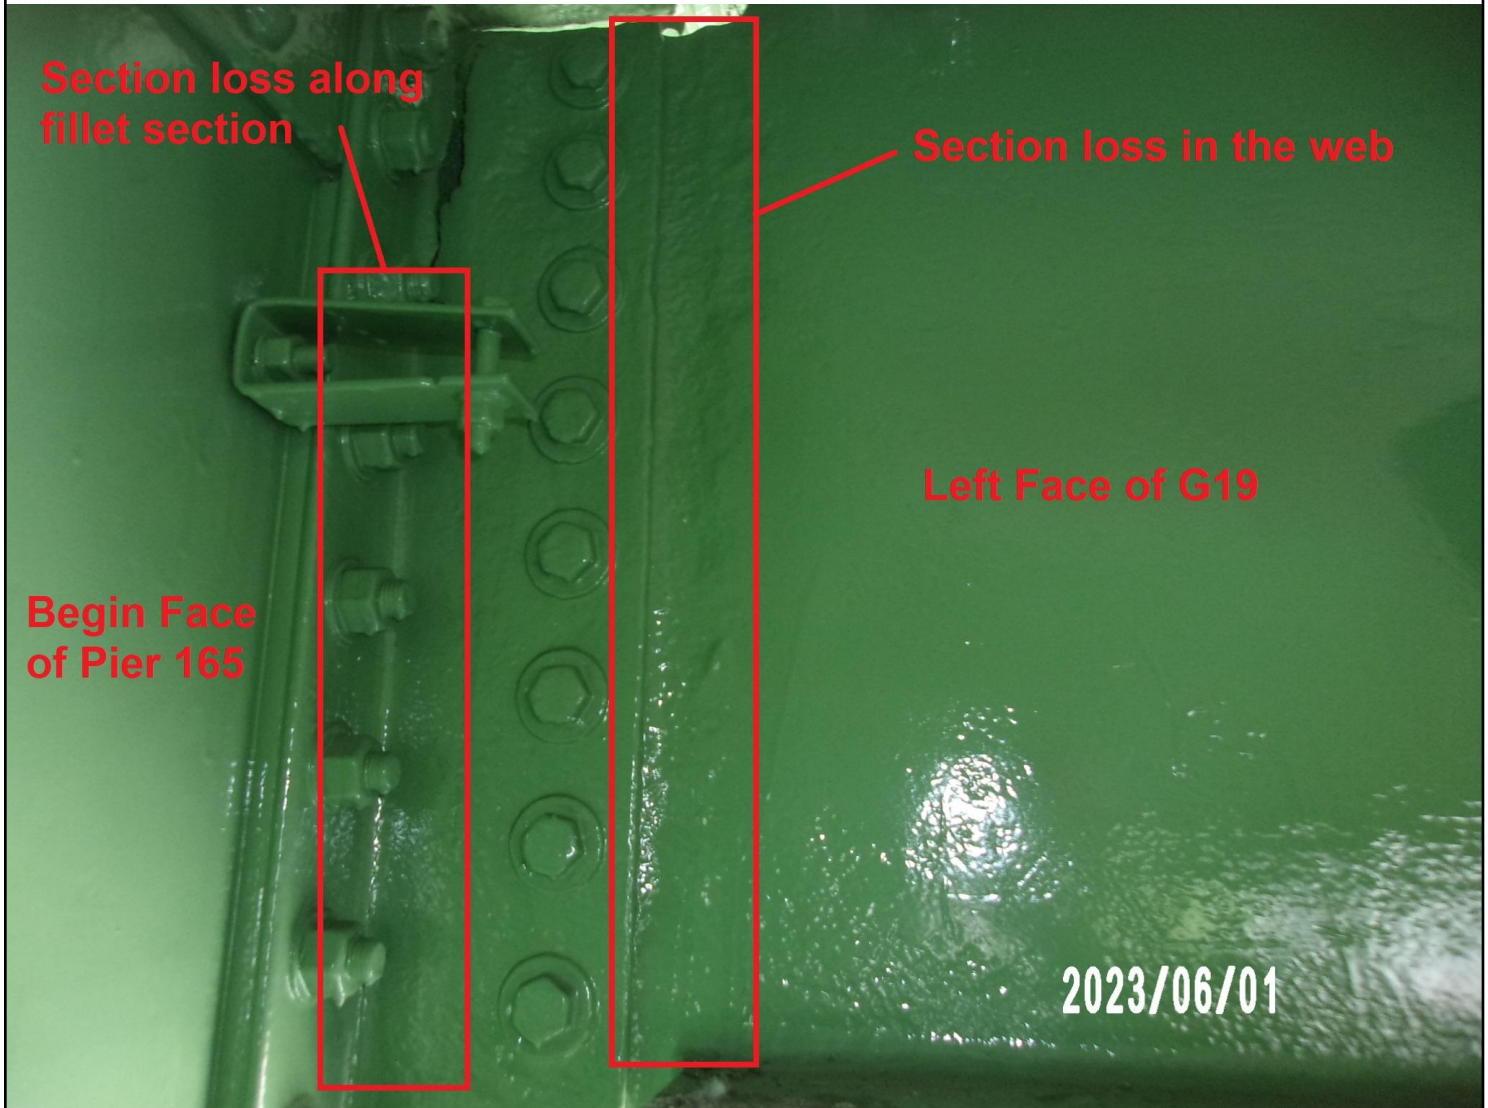
Photo Number: 5

**Attachment Description:** The left face of Girder G19 in Span 165 at Pier 165. The girder web exhibits section loss for the full web height along the connection angle with average section loss of 40% and overall shear web area section loss of 39%. Also, the left connection angle exhibits up to 30% section loss in the fillet section below the crack at the top of the angle. Looking Right.

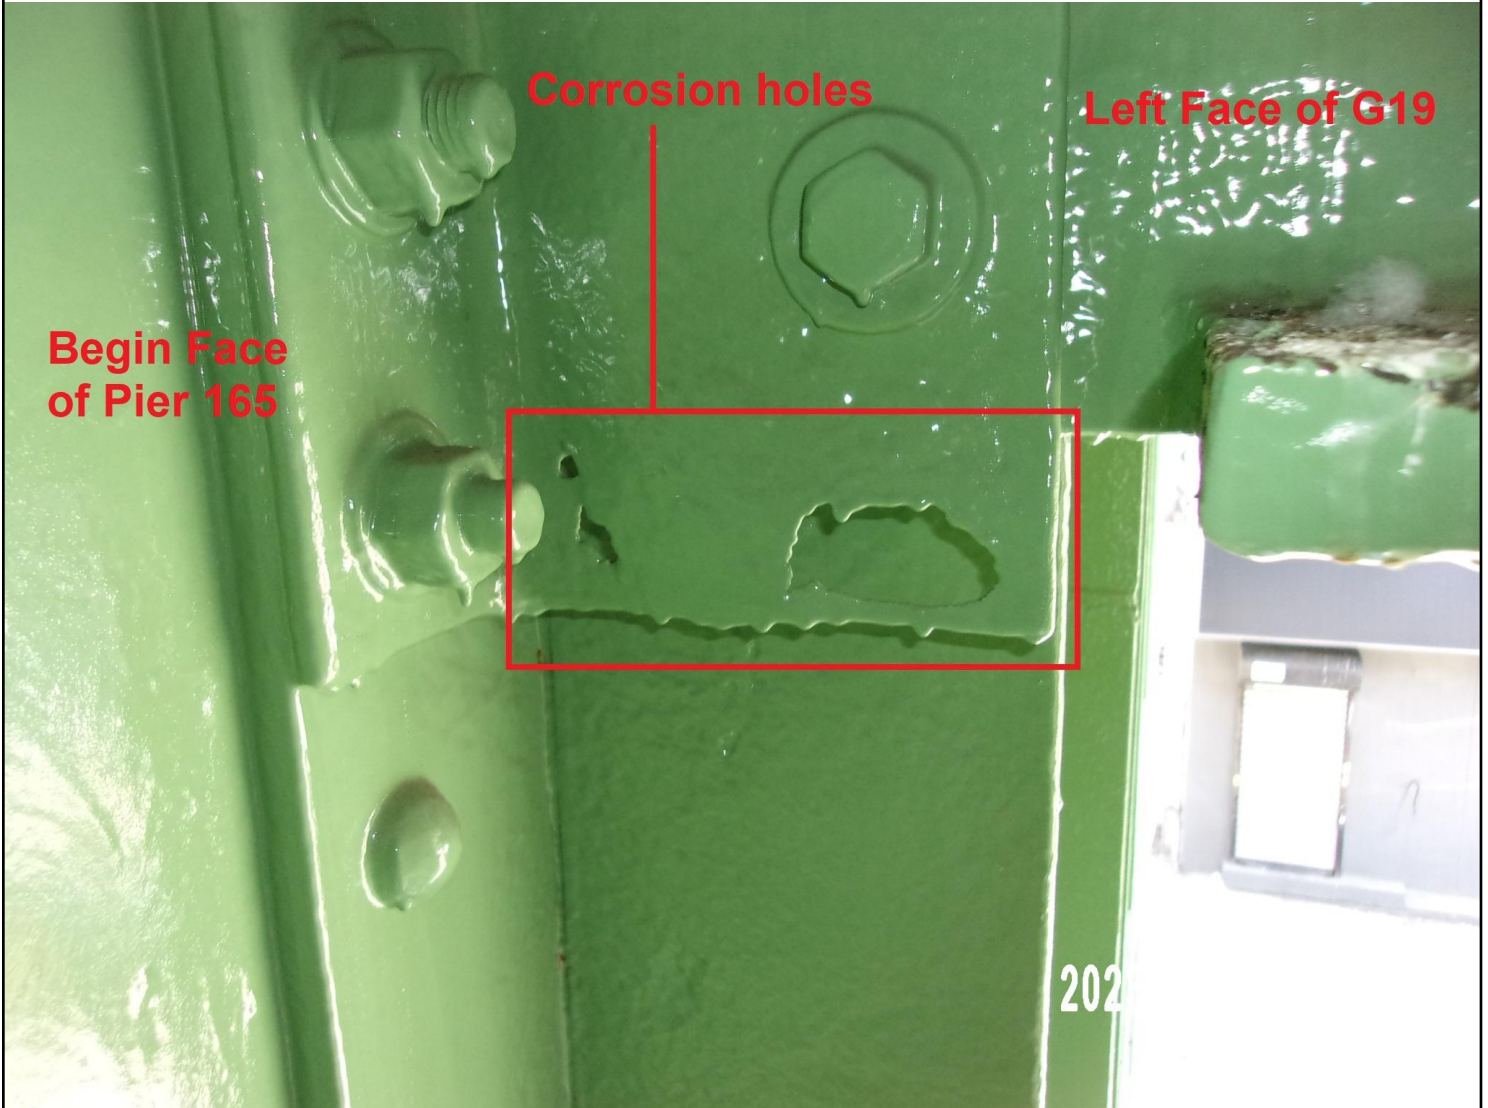
Photo Number: 6

**Attachment Description:** The left face of Girder G19 in Span 165 at Pier 165. The bottom of the left connection angle exhibits three corrosion holes ranging from 1/2" diameter to 2-1/4"L x 1"H. Looking Right.

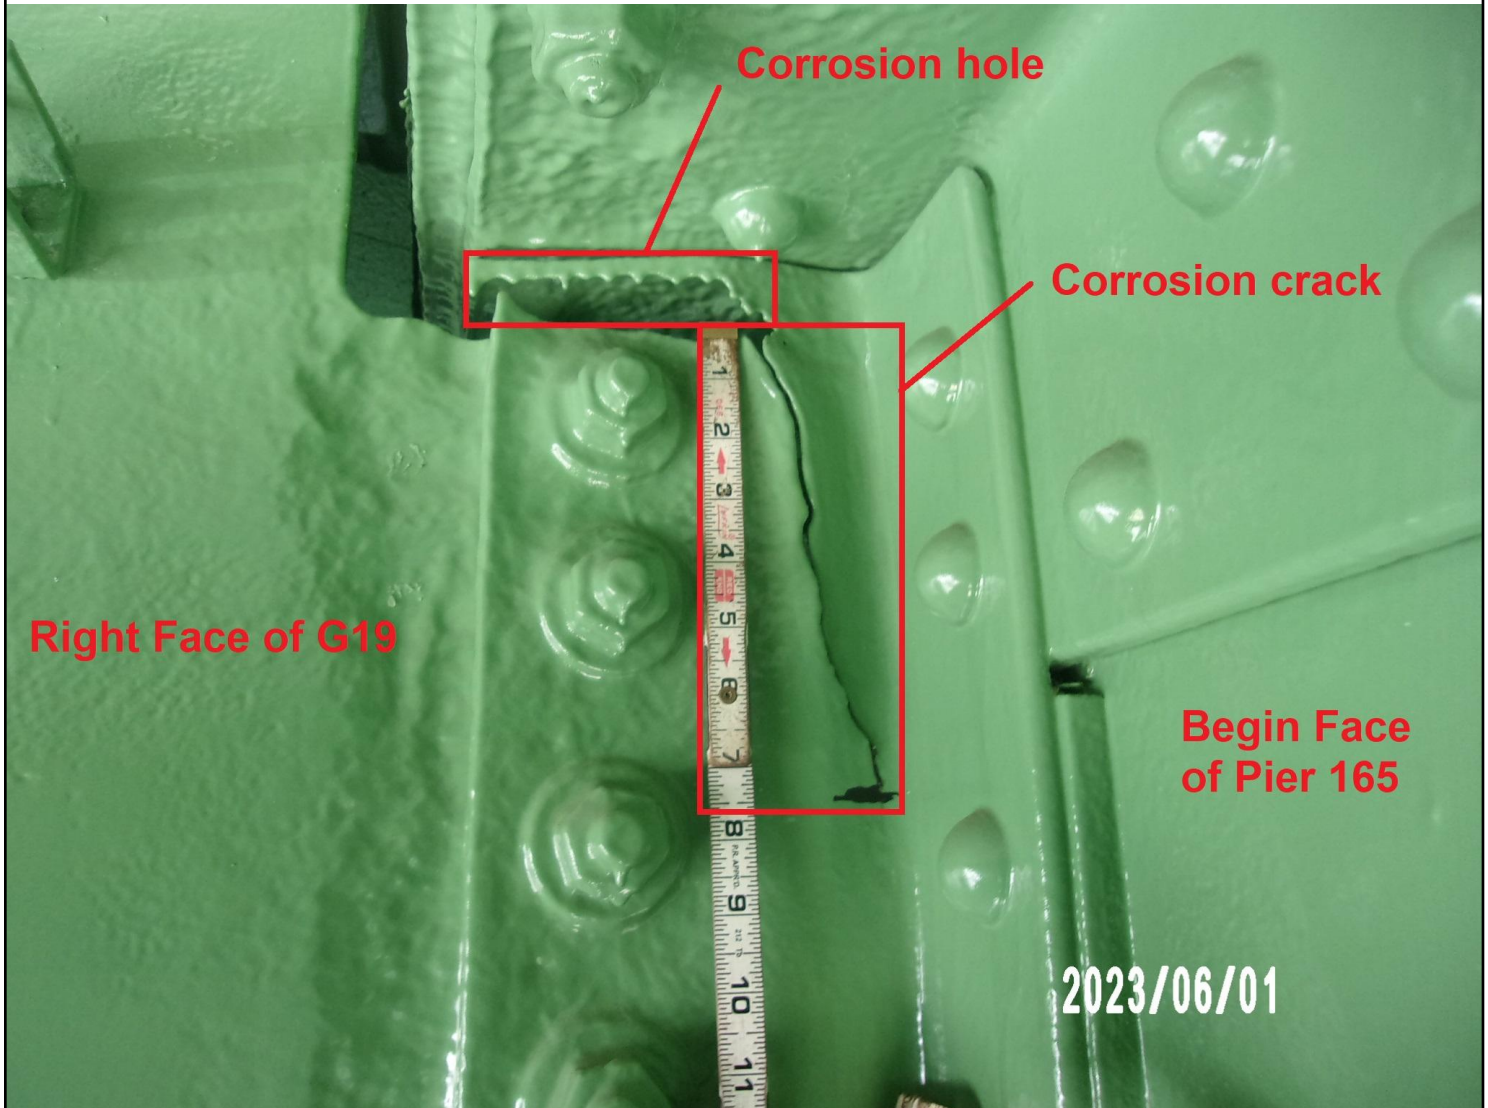
Photo Number: 7

The right stiffener connection angle exhibits a 7-1/2"H x 1/4"W (no changes since previous inspection) diagonal corrosion crack stemming from the 4"L x 1"H corrosion hole at the top of the connection angle and continuing into the upper fillet section (Photo 7). The remaining 20-1/2" area of the fillet section below the corrosion crack at the top of the angle to the bottom of the girder exhibits up to 30% section loss (Photo 8). The remaining portion of the stiffener connection angle from the bottom of the girder to the pier bottom flange (approximately 66" high) is in good condition.

**Attachment Description:** The right face of Girder G19 in Span 165 at Pier 165. The top of the right stiffener connection angle exhibits 7-1/2"H x 1/4"W corrosion crack stemming from the 4"L x 1"H corrosion hole at the top of the angle and continuing into the fillet section. Looking Left.

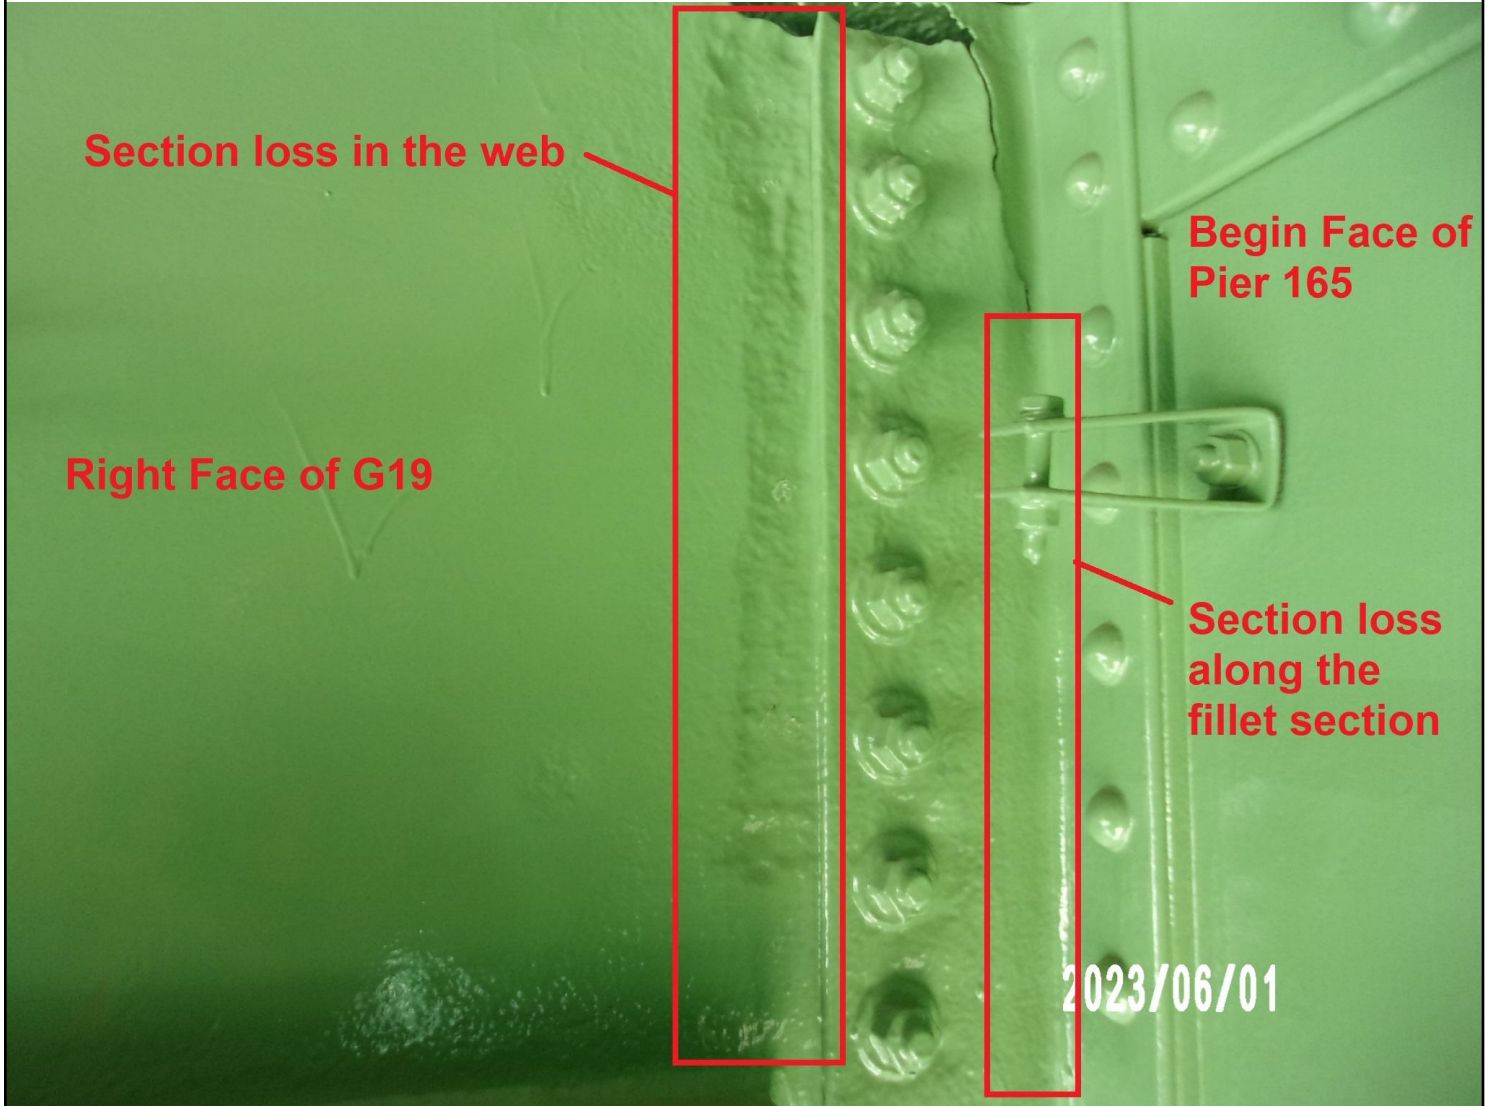
Photo Number: 8

**Attachment Description:** The right face of Girder G19 in Span 165 at Pier 165. The girder web exhibits section loss for the full web height along the connection angle with average section loss of 40% and overall shear web area section loss of 39%. Also, the right stiffener connection angle exhibits up to 30% section loss in the fillet section below the crack at the top of the angle. Looking Left.
